**TEST REPORT**

ENVIRONMENTAL TESTING OF THE P/N PG800UPS UPS

**AJ'S POWER SOURCE, INC.**  
6931 Land O' Lakes Boulevard  
Land O' Lakes, Florida 34638

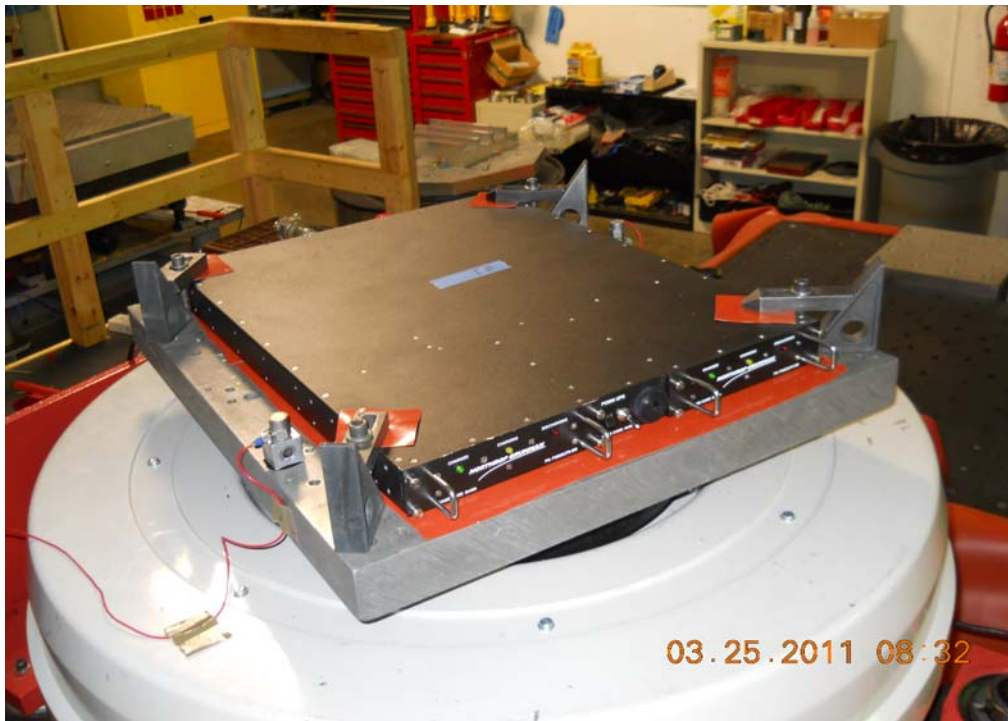
**Figure 1-1: Test setup for vertical-axis composite wheeled vehicle vibration.**

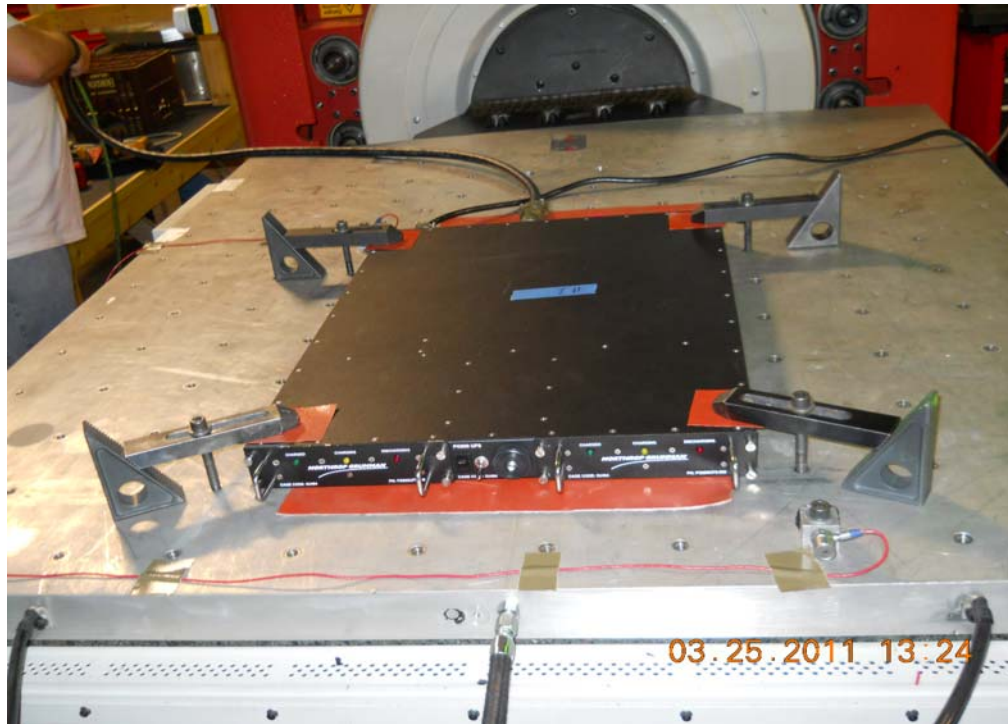
**Figure 1-2: Test setup for longitudinal-axis composite wheeled vehicle vibration.**

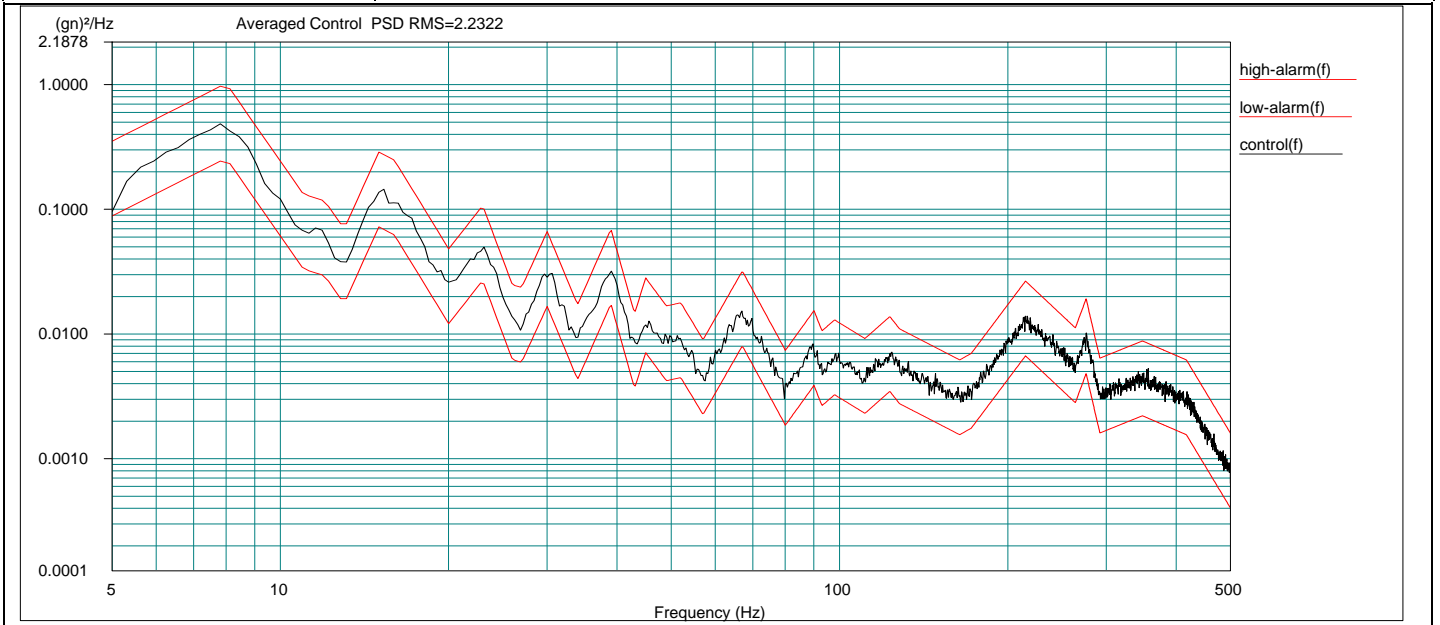
Qualtest, Inc. 5325 Old Winter Garden Road Orlando, Florida 32811 Tel. (407) 293-5844 Fax (407) 297-7376	Customer:		AJs Power Source, Inc.		
	Test Hardware:		UPS	Job #:	07569
	P/N:		PG800UPS	Run #:	1
	S/N:		marked "#1"	Axis:	Vertical
	Date:	21 March 2011	Time:	1609	Duration:

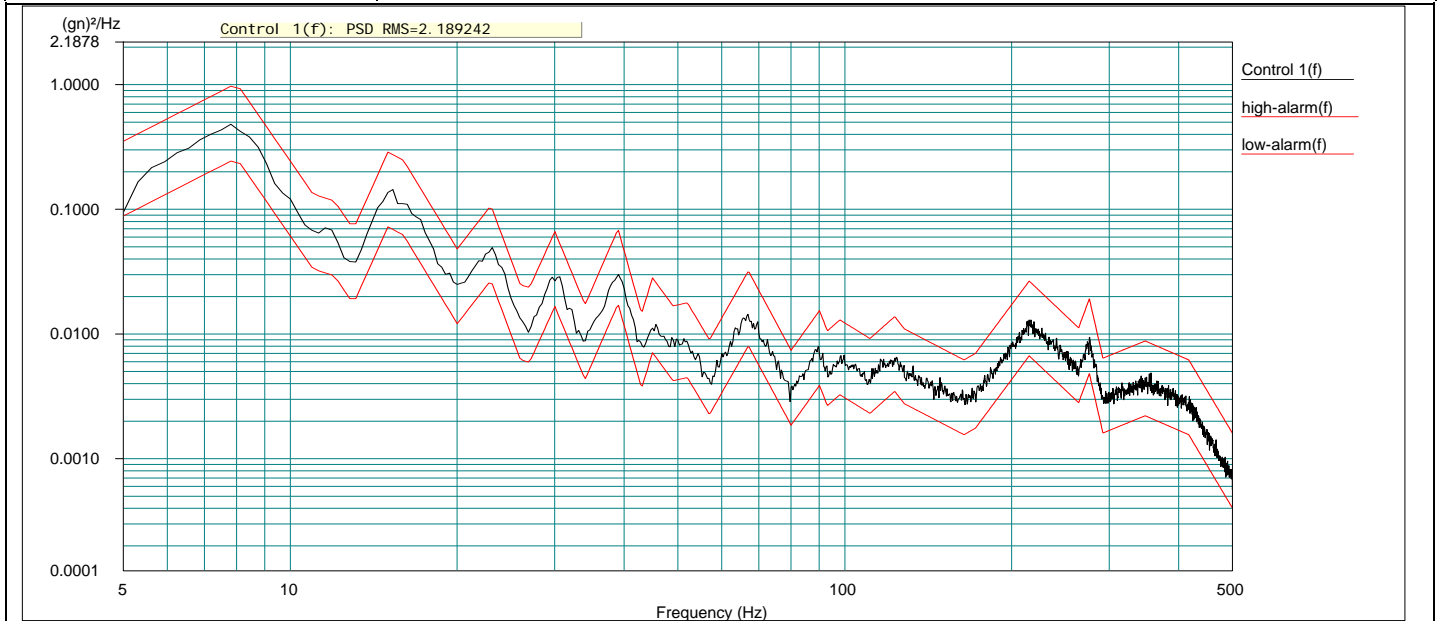
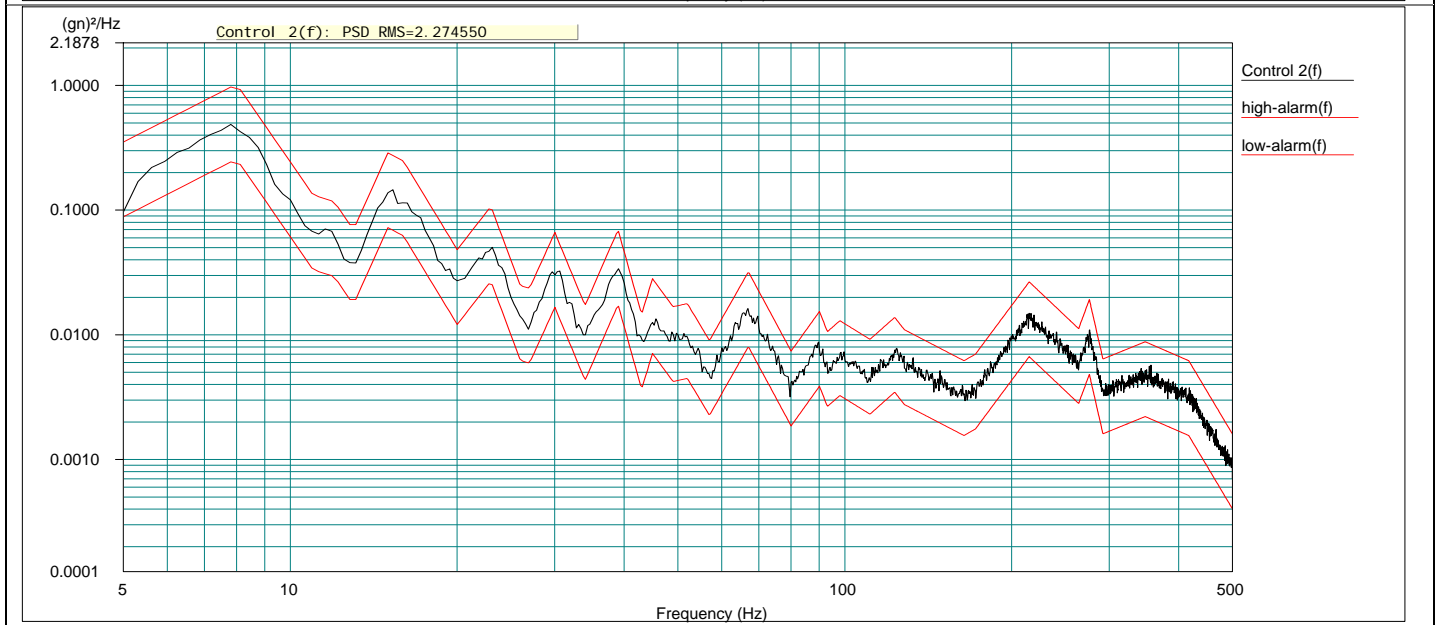
Qualtest, Inc. 5325 Old Winter Garden Road Orlando, Florida 32811 Tel. (407) 293-5844 Fax (407) 297-7376	Customer:		AJs Power Source, Inc.		
	Test Hardware:		UPS	Job #:	07569
	P/N:		PG800UPS	Run #:	1
	S/N:		marked "#1"	Axis:	Vertical
	Date:	21 March 2011	Time:	1609	Duration:

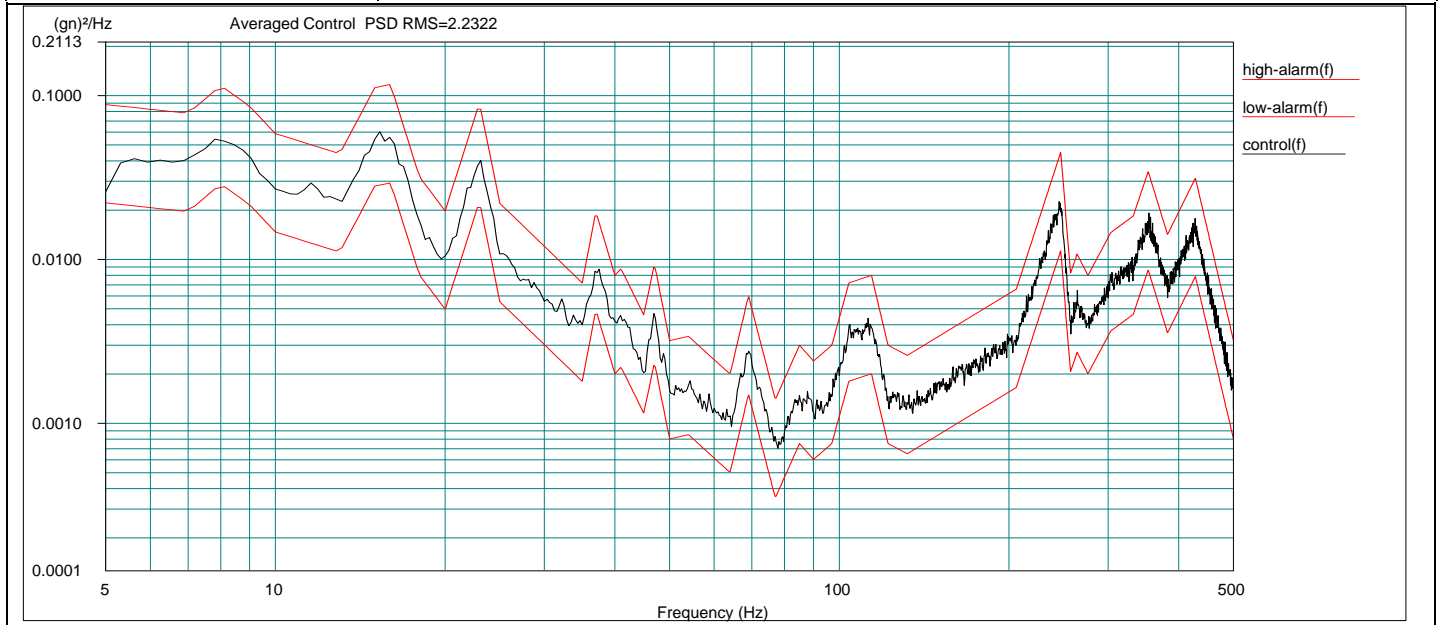
Qualtest, Inc. 5325 Old Winter Garden Road Orlando, Florida 32811 Tel. (407) 293-5844 Fax (407) 297-7376	Customer:		AJs Power Source, Inc.	
	Test Hardware:		UPS	Job #: 07569
	P/N:		PG800UPS	Run #: 2
	S/N:		marked "#1"	Axis: Longitudinal
	Date:	22 March 2011	Time:	1221
		Duration:	2 hours

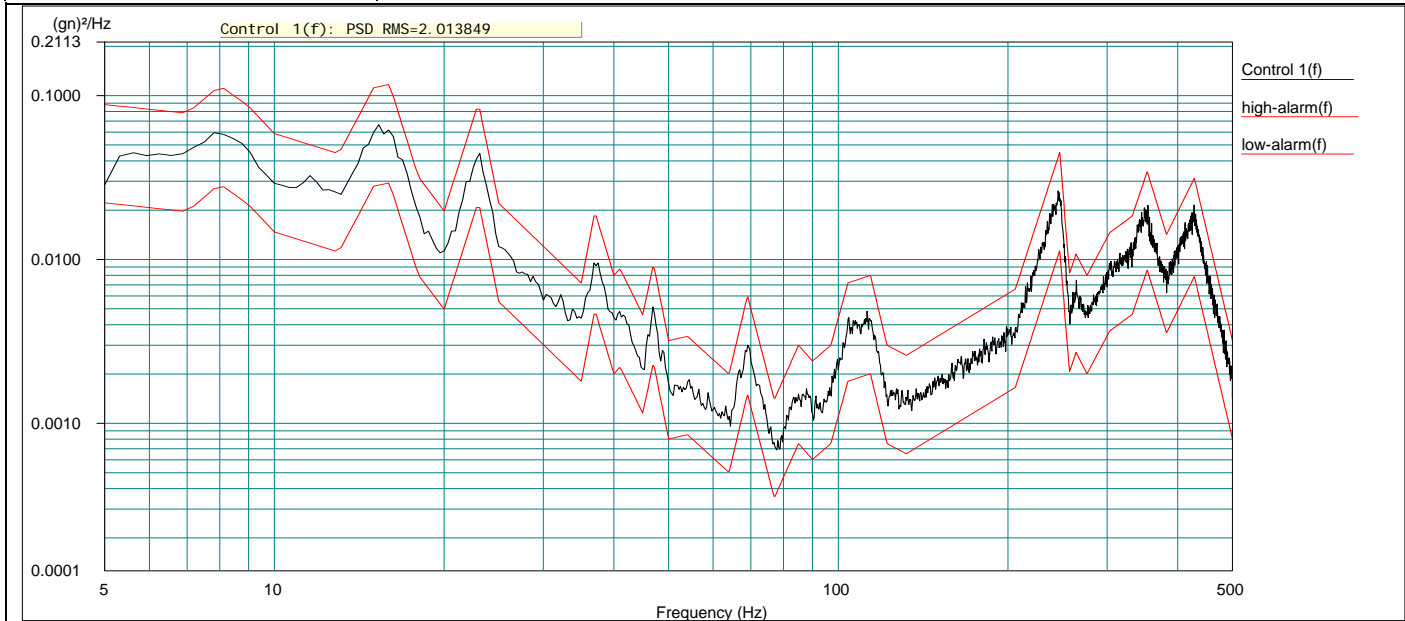
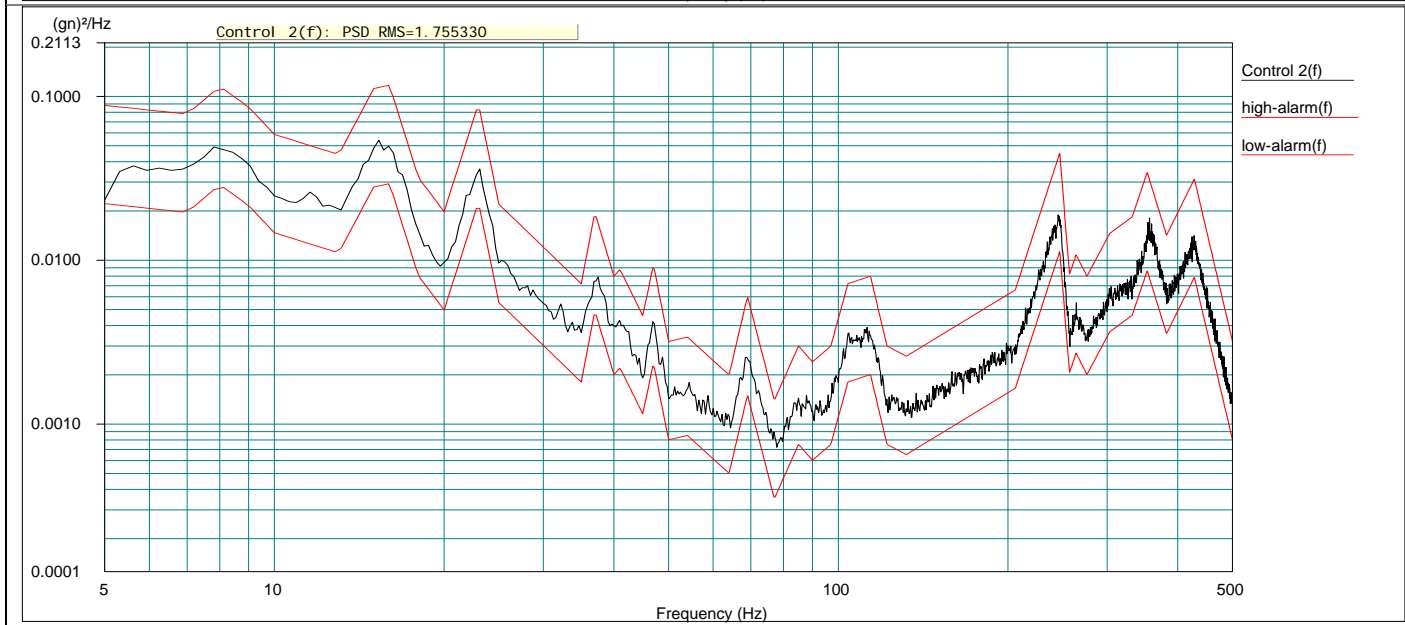
Qualtest, Inc. 5325 Old Winter Garden Road Orlando, Florida 32811 Tel. (407) 293-5844 Fax (407) 297-7376	Customer:		AJs Power Source, Inc.		
	Test Hardware:		UPS	Job #:	07569
	P/N:		PG800UPS	Run #:	2
	S/N:		marked "#1"	Axis:	Longitudinal
	Date:	22 March 2011	Time:	1221	Duration:

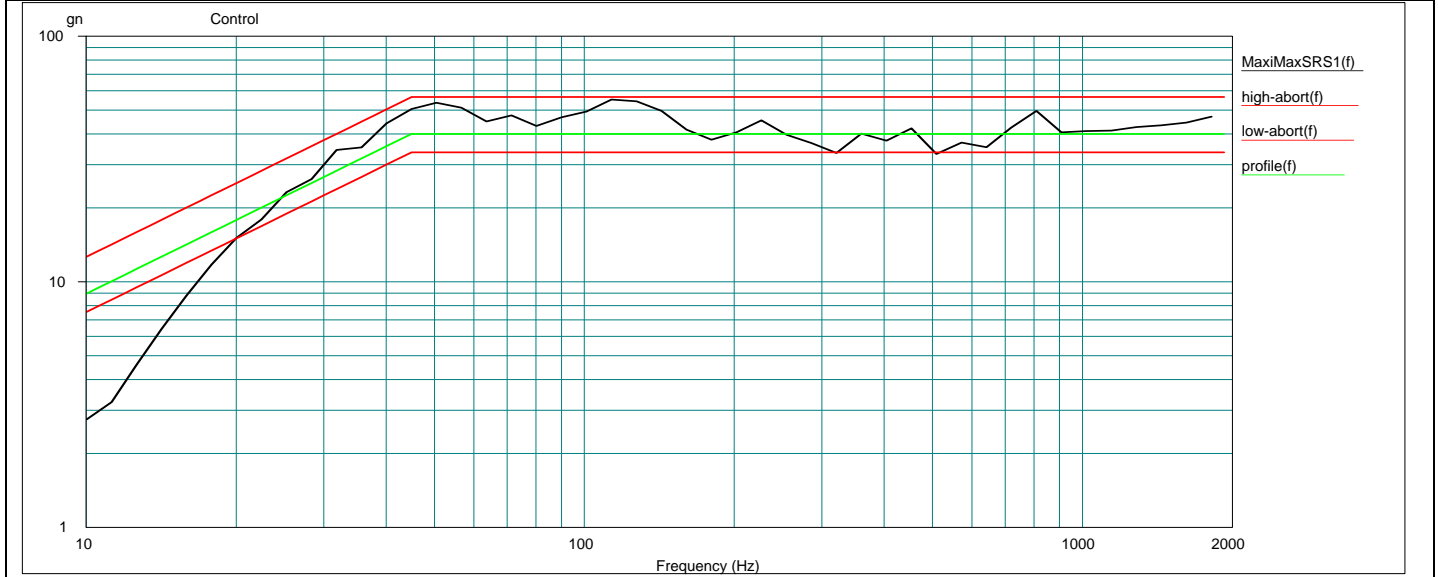
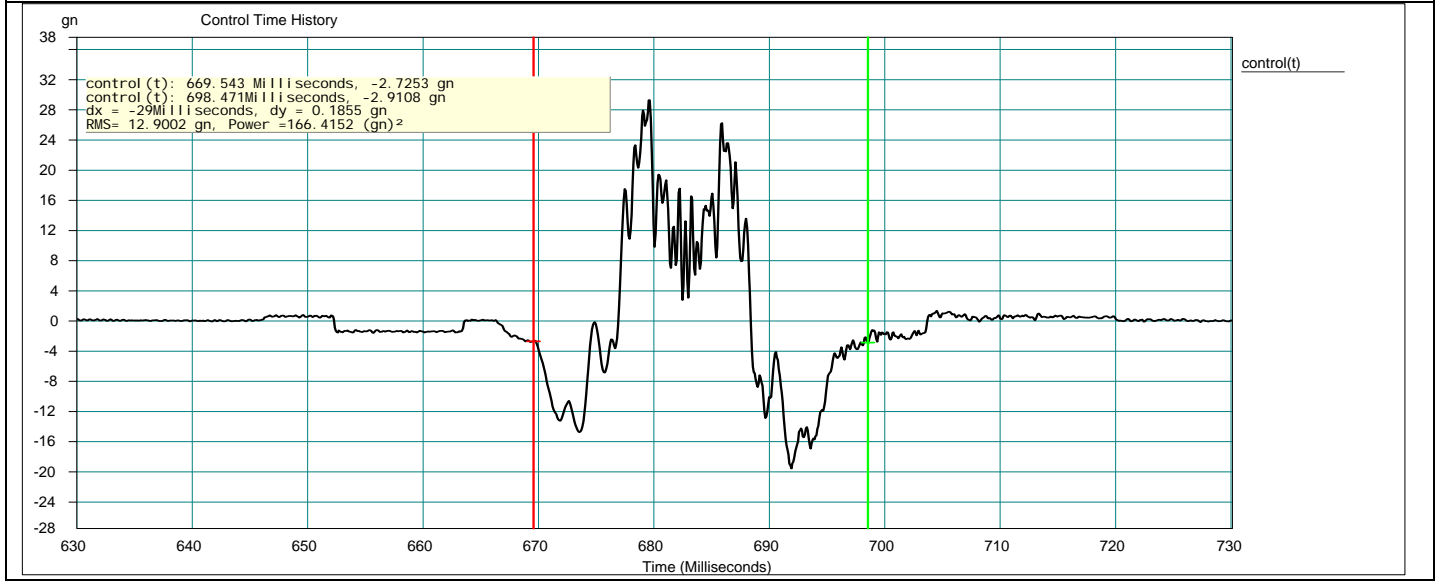
Qualtest, Inc. 5325 Old Winter Garden Road Orlando, Florida 32811 Tel. (407) 293-5844 Fax (407) 297-7376	Customer:	AJs Power Source, Inc.	Job #:	07569
	Test Hardware:	UPS	Shock #:	1 Pulse 1
	P/N:	PG800UPS	Axis:	Vertical
	S/N:	marked "#1"	Direction:	Positive
	Date:	22 March 2011	Time:	0814

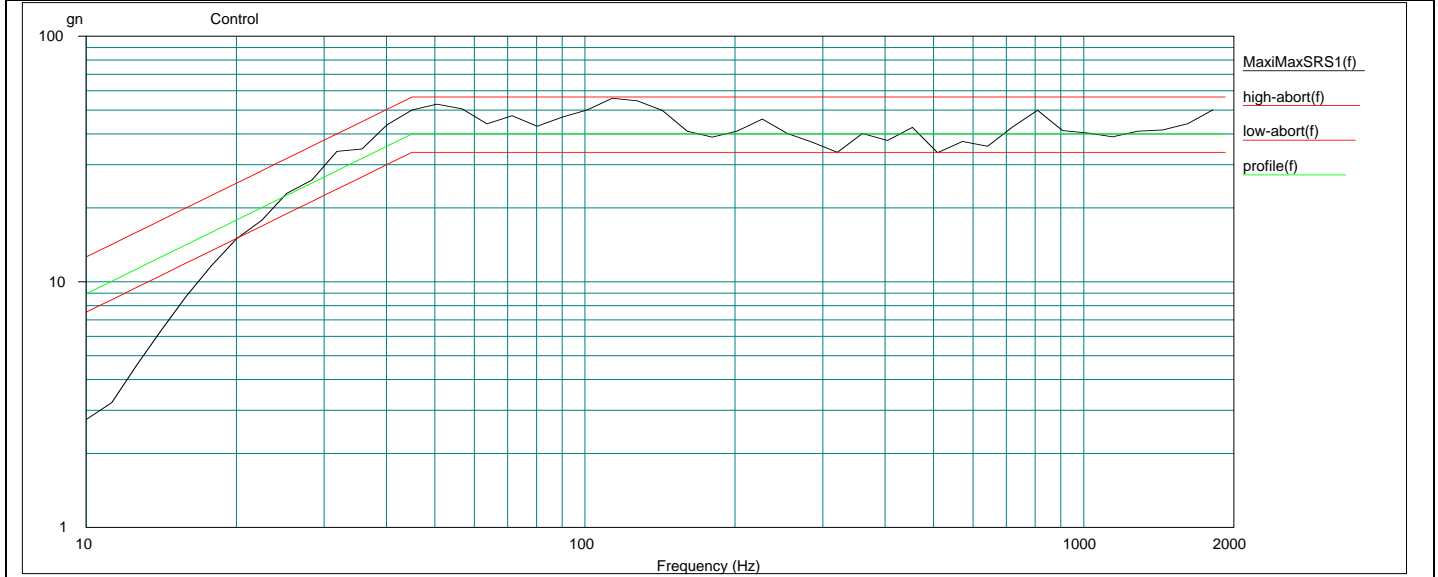
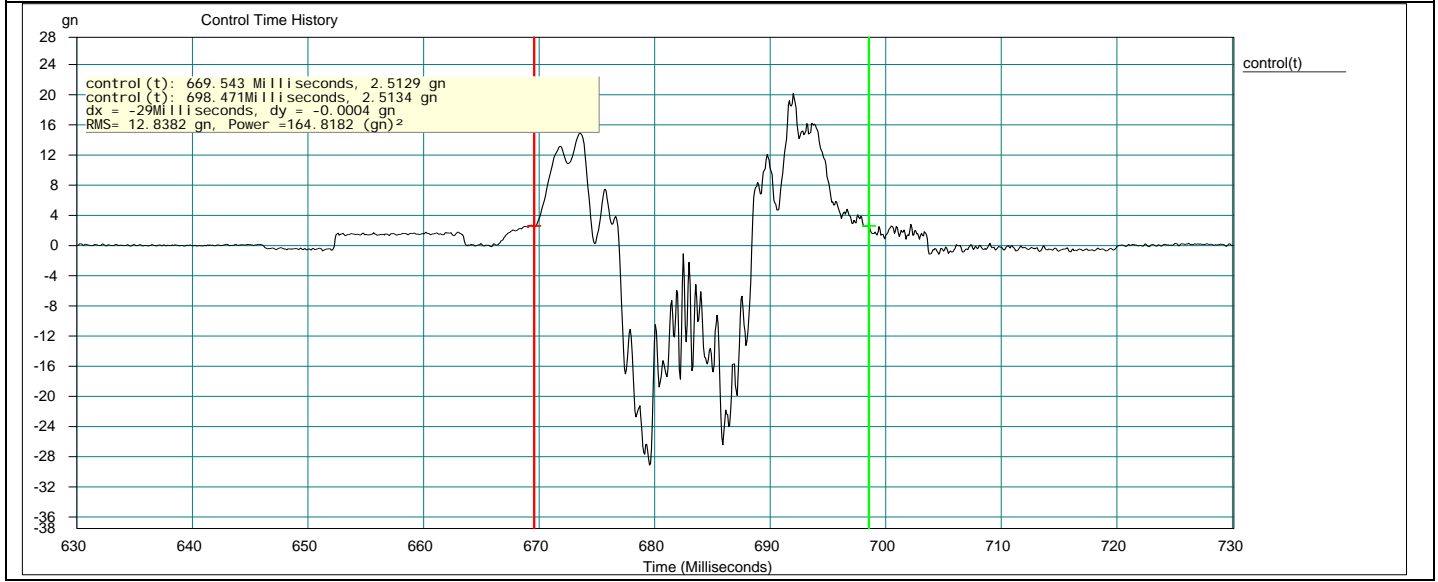
Qualtest, Inc. 5325 Old Winter Garden Road Orlando, Florida 32811 Tel. (407) 293-5844 Fax (407) 297-7376	Customer:	AJs Power Source, Inc.	Job #:	07569
	Test Hardware:	UPS	Shock #:	2 Pulse 1
	P/N:	PG800UPS	Axis:	Vertical
	S/N:	marked "#1"	Direction:	Negative
	Date:	22 March 2011	Time:	0821

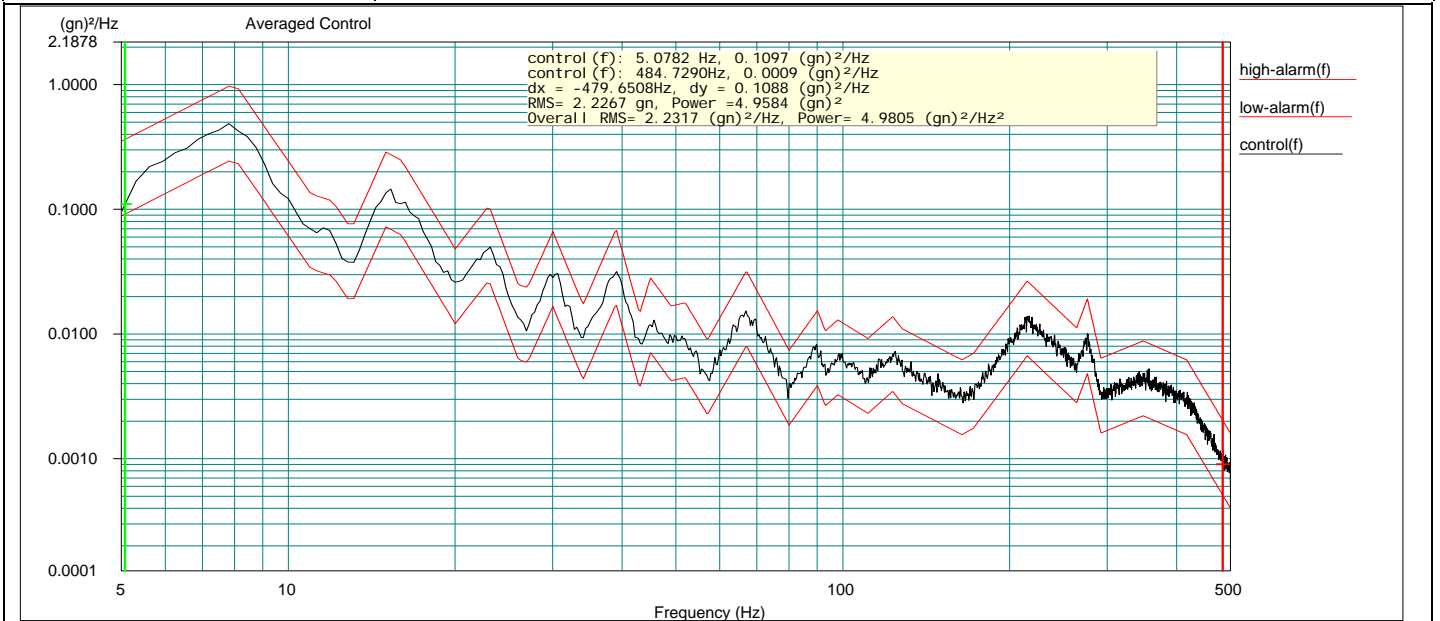
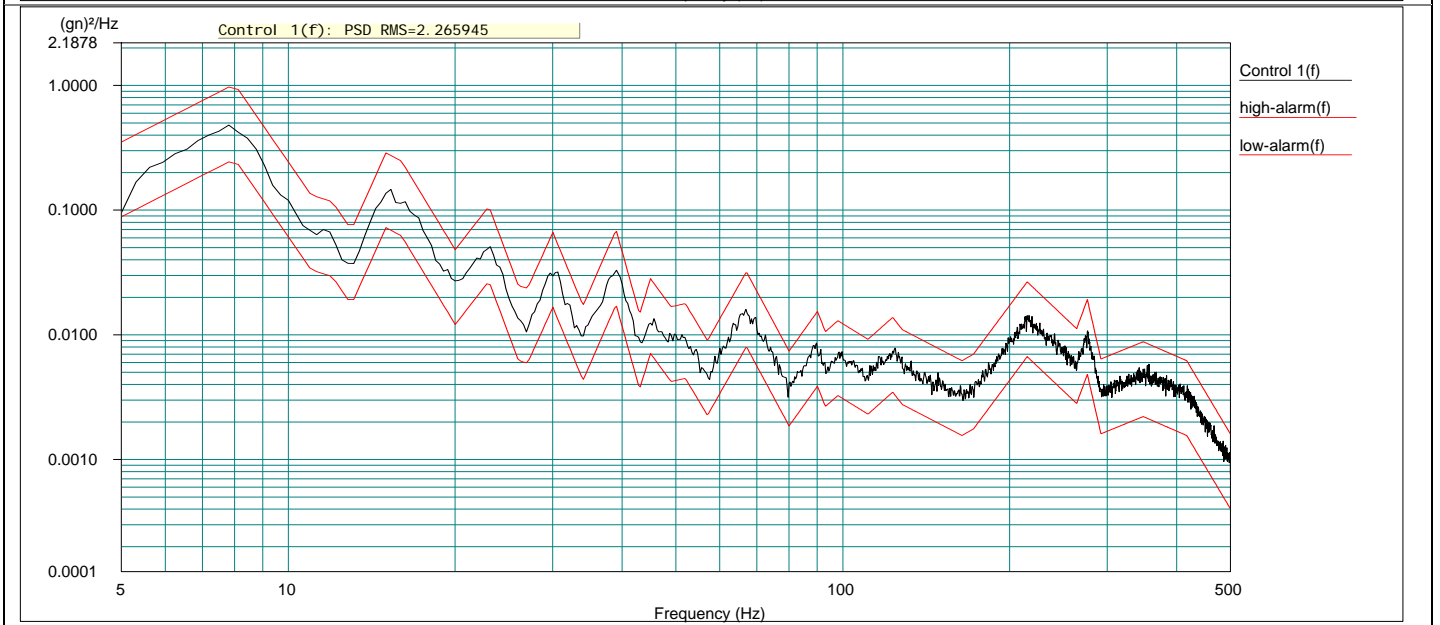
Qualtest, Inc. 5325 Old Winter Garden Road Orlando, Florida 32811 Tel. (407) 293-5844 Fax (407) 297-7376	Customer:		AJs Power Source, Inc.		
	Test Hardware:		UPS (1 ea.)	Job #:	07569
	P/N:		PG800UPS	Run #:	1
	S/N:		marked "#1"	Axis:	Vertical
	Date:	25 March 2011	Time:	1044	Duration:

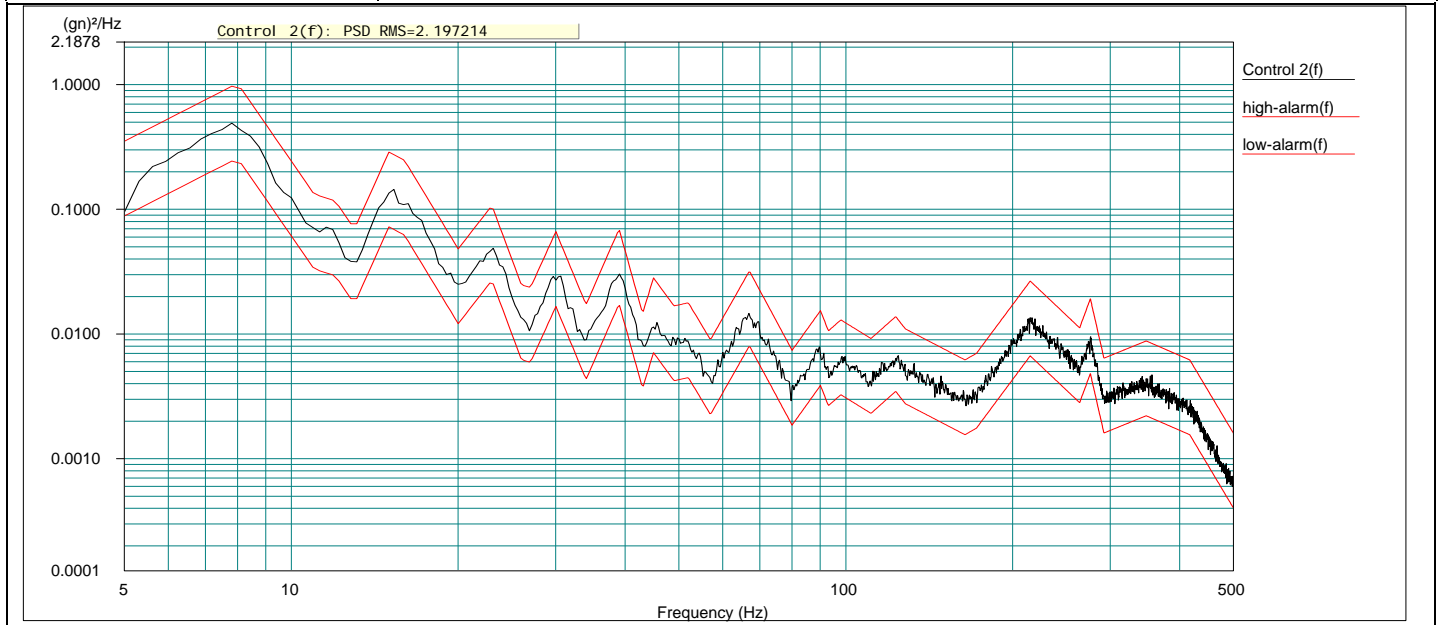
Qualtest, Inc. 5325 Old Winter Garden Road Orlando, Florida 32811 Tel. (407) 293-5844 Fax (407) 297-7376	Customer:		AJs Power Source, Inc.		
	Test Hardware:		UPS (1 ea.)	Job #:	07569
	P/N:		PG800UPS	Run #:	1
	S/N:		marked "#1"	Axis:	Vertical
	Date:	25 March 2011	Time:	1044	Duration:

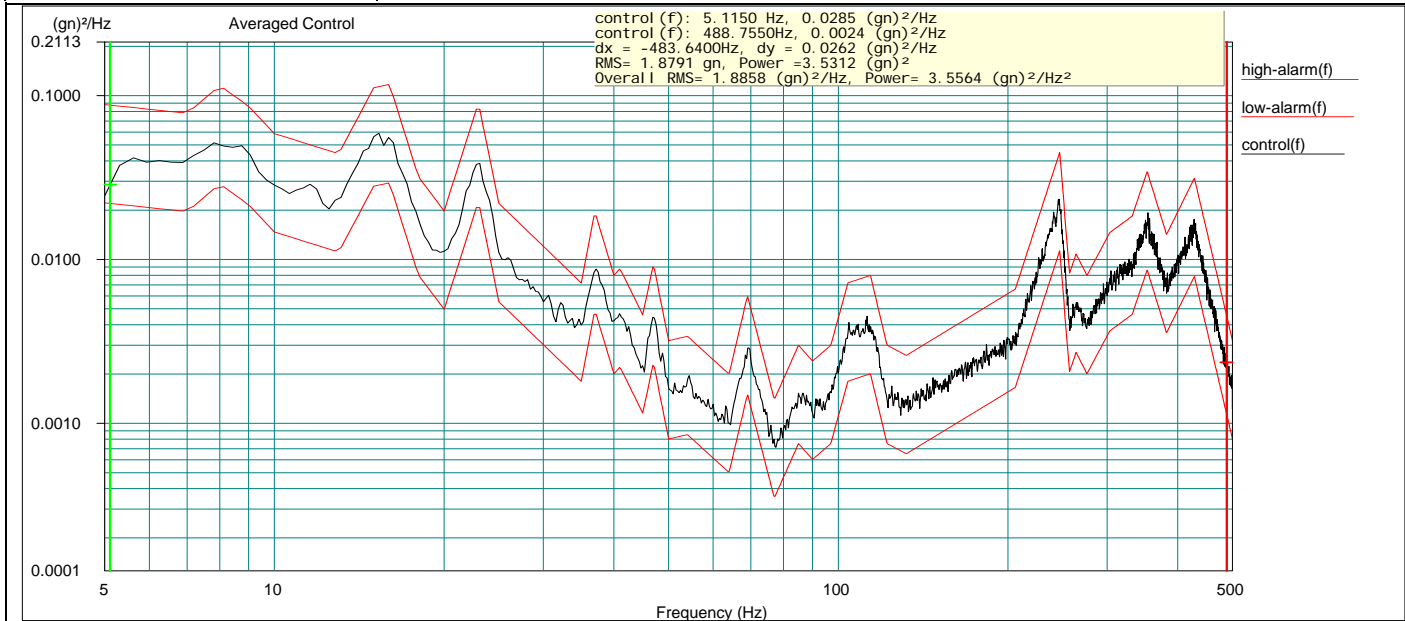
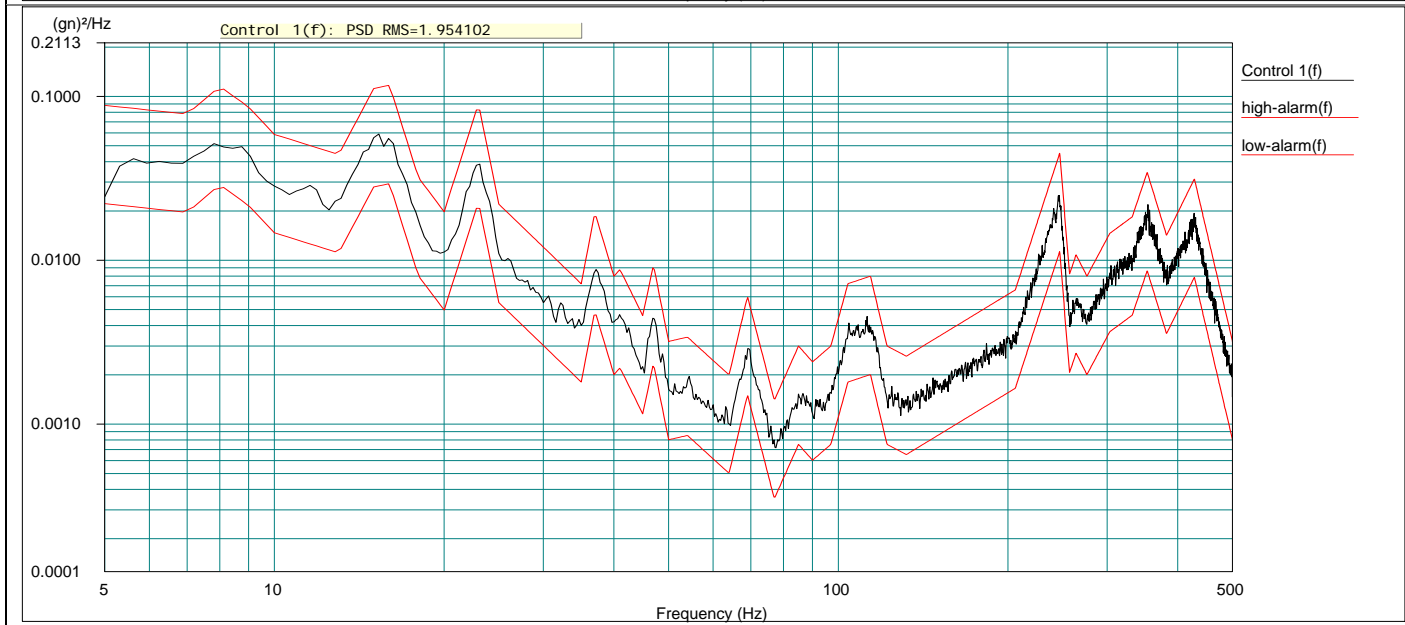
Qualtest, Inc. 5325 Old Winter Garden Road Orlando, Florida 32811 Tel. (407) 293-5844 Fax (407) 297-7376	Customer:		AJs Power Source, Inc.		
	Test Hardware:		UPS (1 ea.)	Job #:	07569
	P/N:		PG800UPS	Run #:	2
	S/N:		marked "#1"	Axis:	Longitudinal
	Date:	25 March 2011	Time:	1632	Duration:

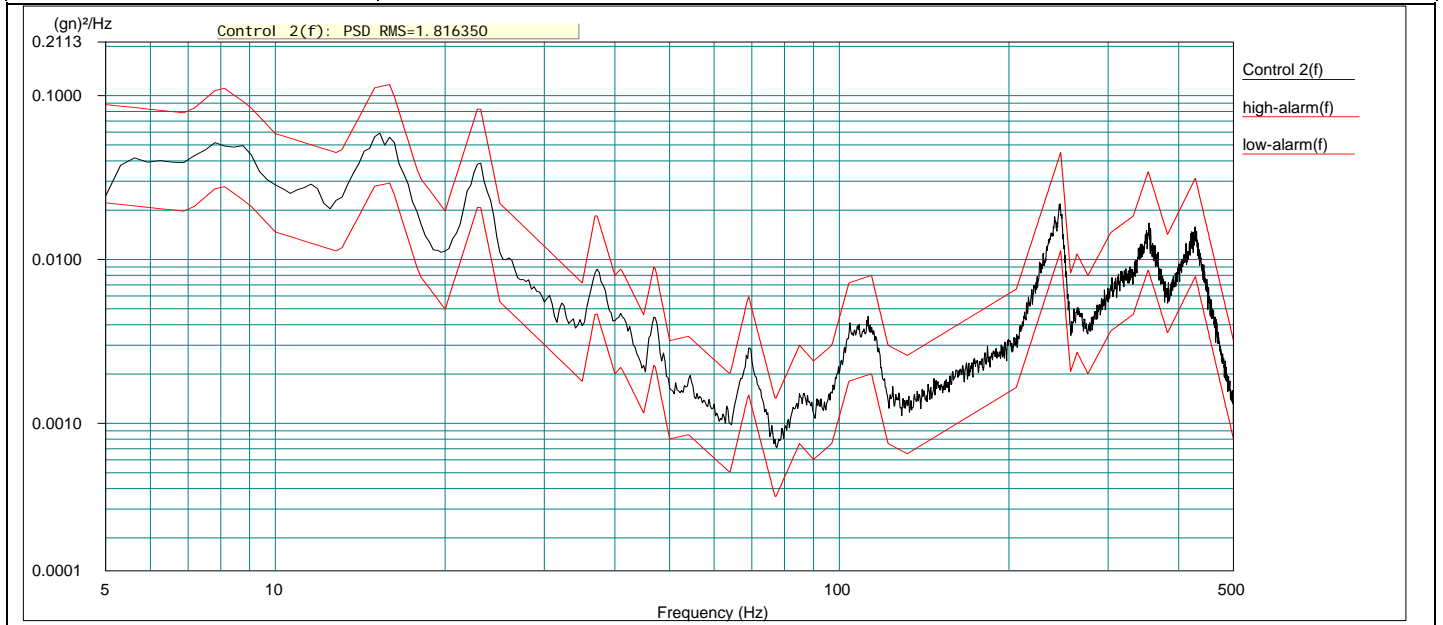
Qualtest, Inc. 5325 Old Winter Garden Road Orlando, Florida 32811 Tel. (407) 293-5844 Fax (407) 297-7376	Customer:		AJs Power Source, Inc.		
	Test Hardware:		UPS (1 ea.)	Job #:	07569
	P/N:		PG800UPS	Run #:	2
	S/N:		marked "#1"	Axis:	Longitudinal
	Date:	25 March 2011	Time:	1632	Duration:

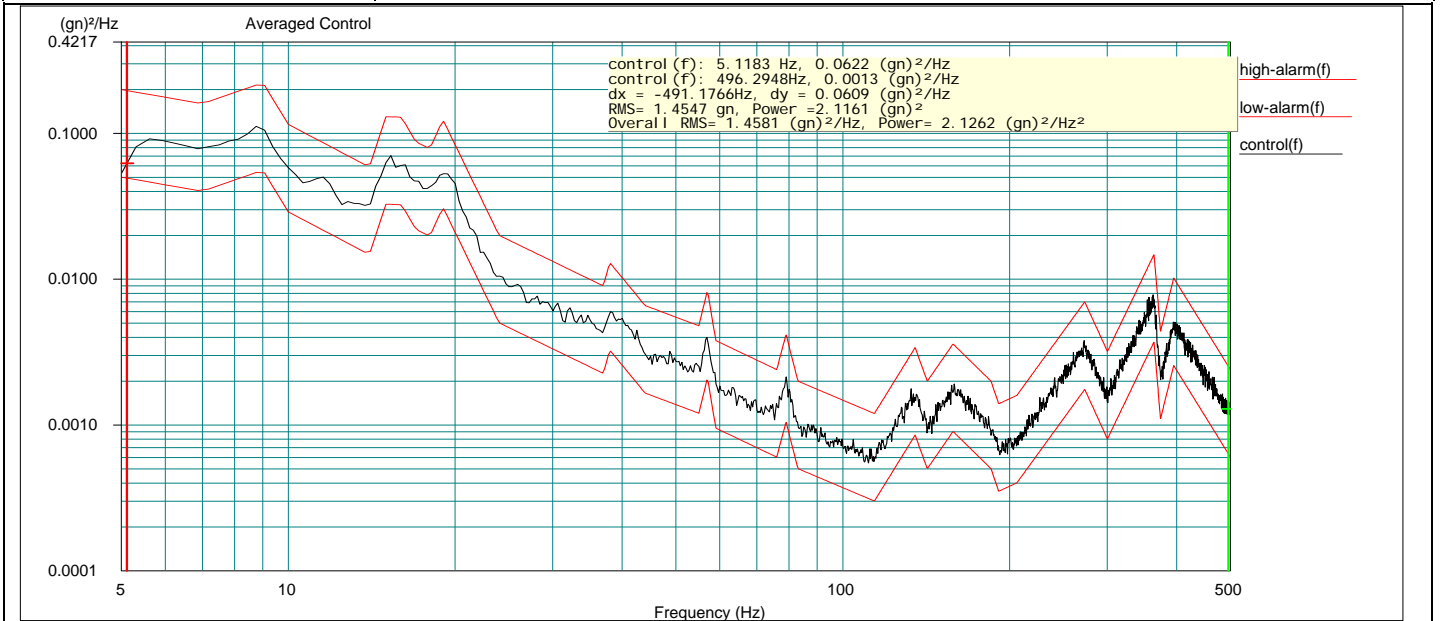
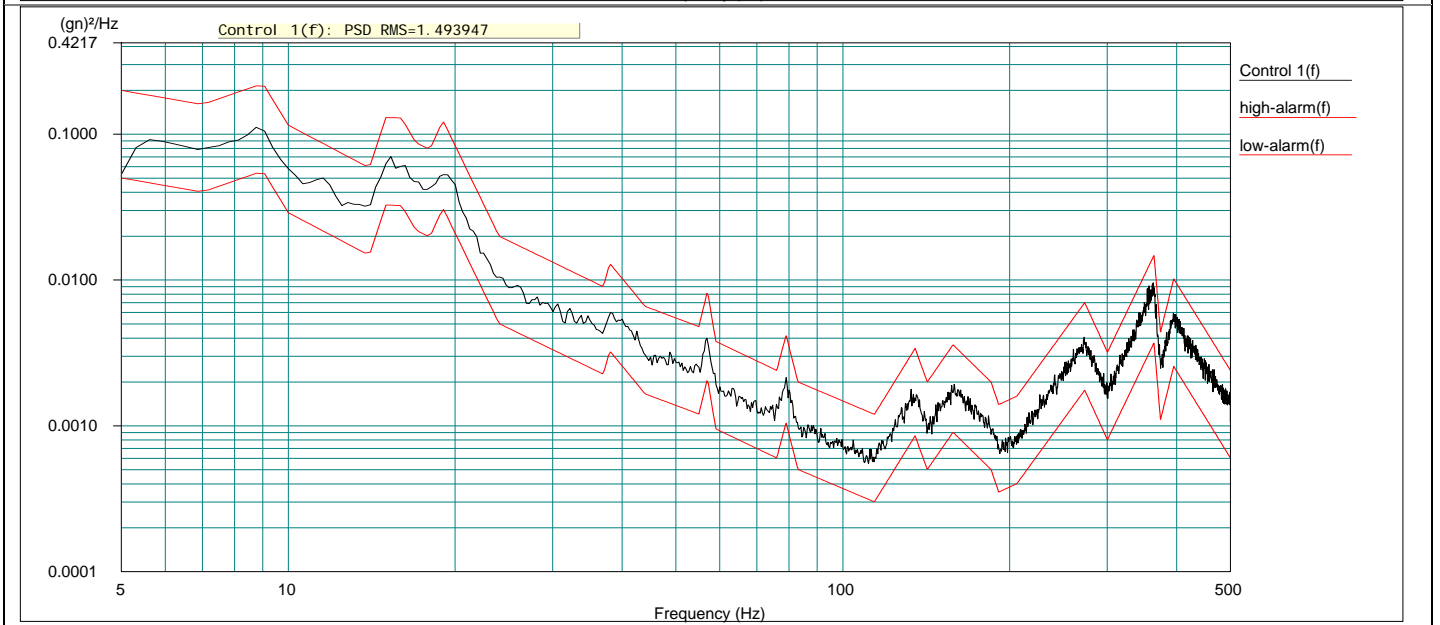
Qualtest, Inc. 5325 Old Winter Garden Road Orlando, Florida 32811 Tel. (407) 293-5844 Fax (407) 297-7376	Customer:		AJs Power Source, Inc.		
	Test Hardware:		UPS (1 ea.)	Job #:	07569
	P/N:		PG800UPS	Run #:	3
	S/N:		marked "#1"	Axis:	Transverse
	Date:	28 March 2011	Time:	0915	Duration:

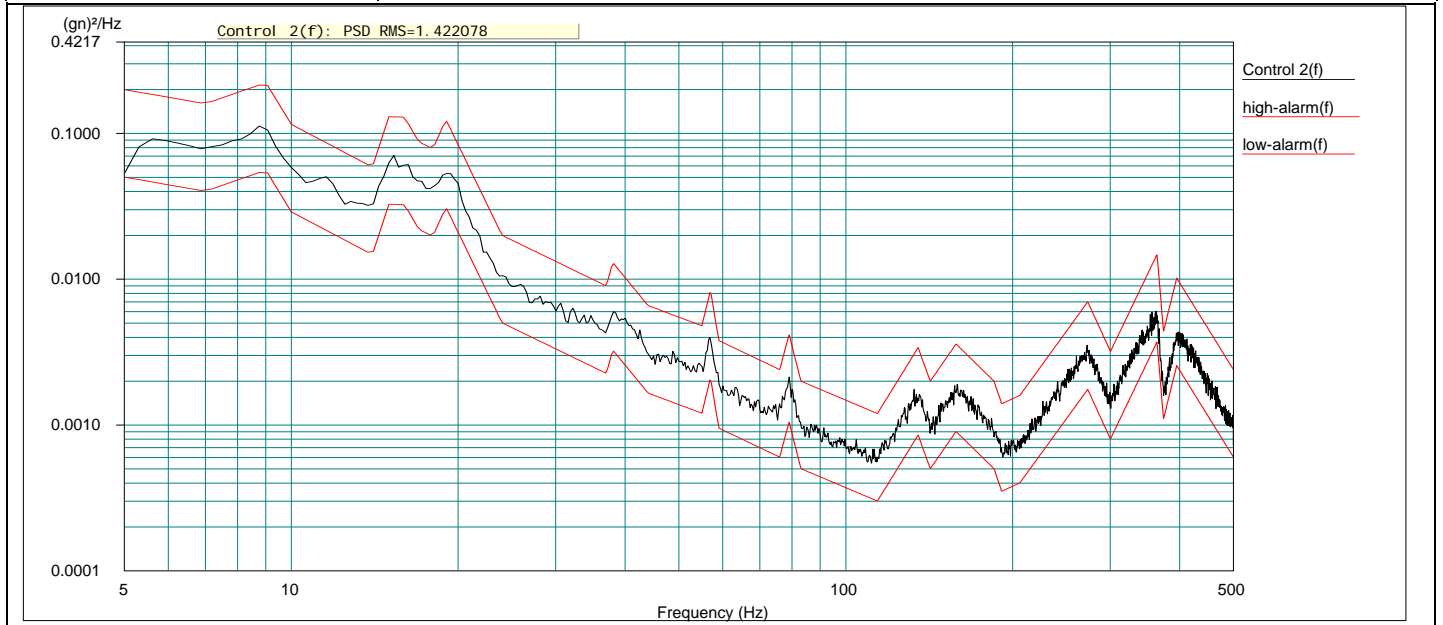
Qualtest, Inc. 5325 Old Winter Garden Road Orlando, Florida 32811 Tel. (407) 293-5844 Fax (407) 297-7376	Customer:		AJs Power Source, Inc.		
	Test Hardware:		UPS (1 ea.)	Job #:	07569
	P/N:		PG800UPS	Run #:	3
	S/N:		marked "#1"	Axis:	Transverse
	Date:	28 March 2011	Time:	0915	Duration:

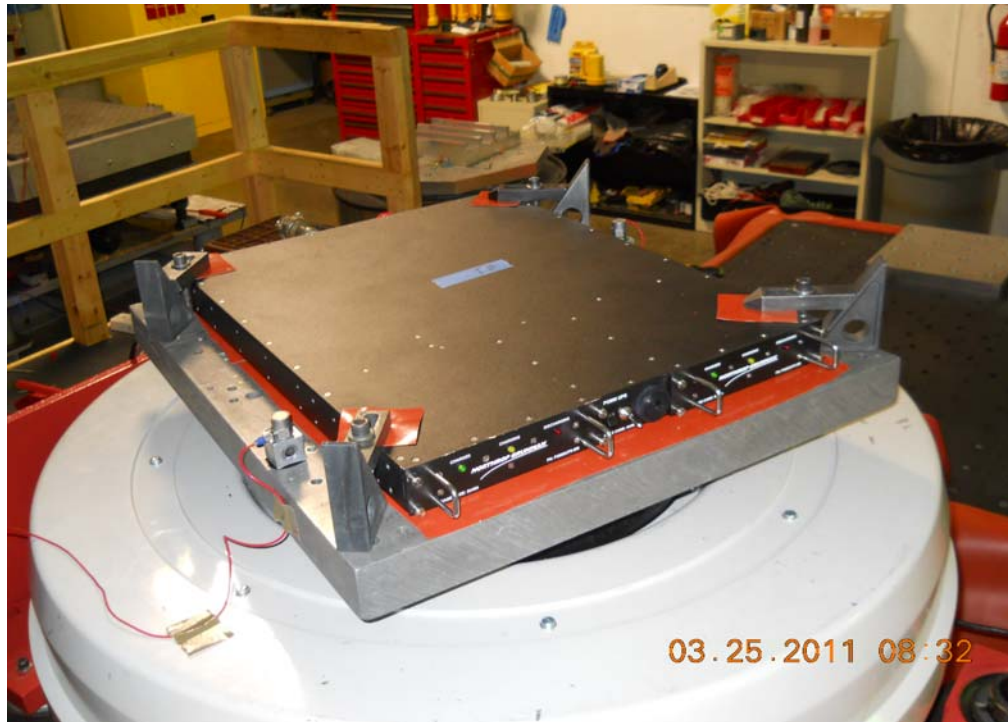
**Figure 4-1: Test setup for vertical-axis SRS shock.**

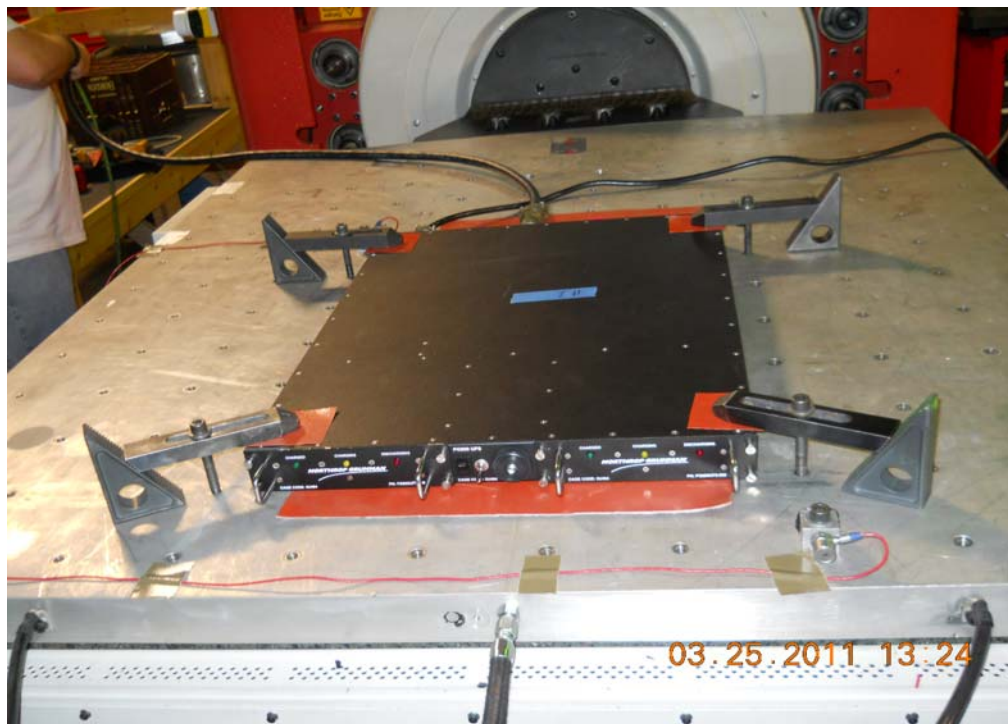
**Figure 4-2: Test setup for longitudinal-axis SRS shock.**

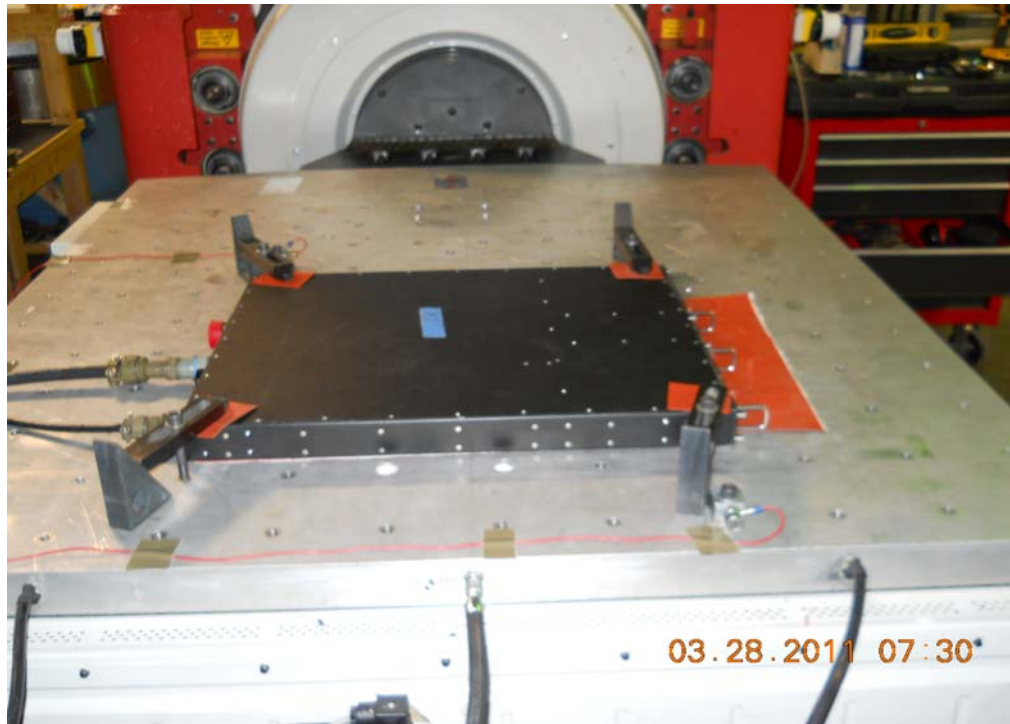
**Figure 4-3: Test setup for transverse-axis SRS shock.**

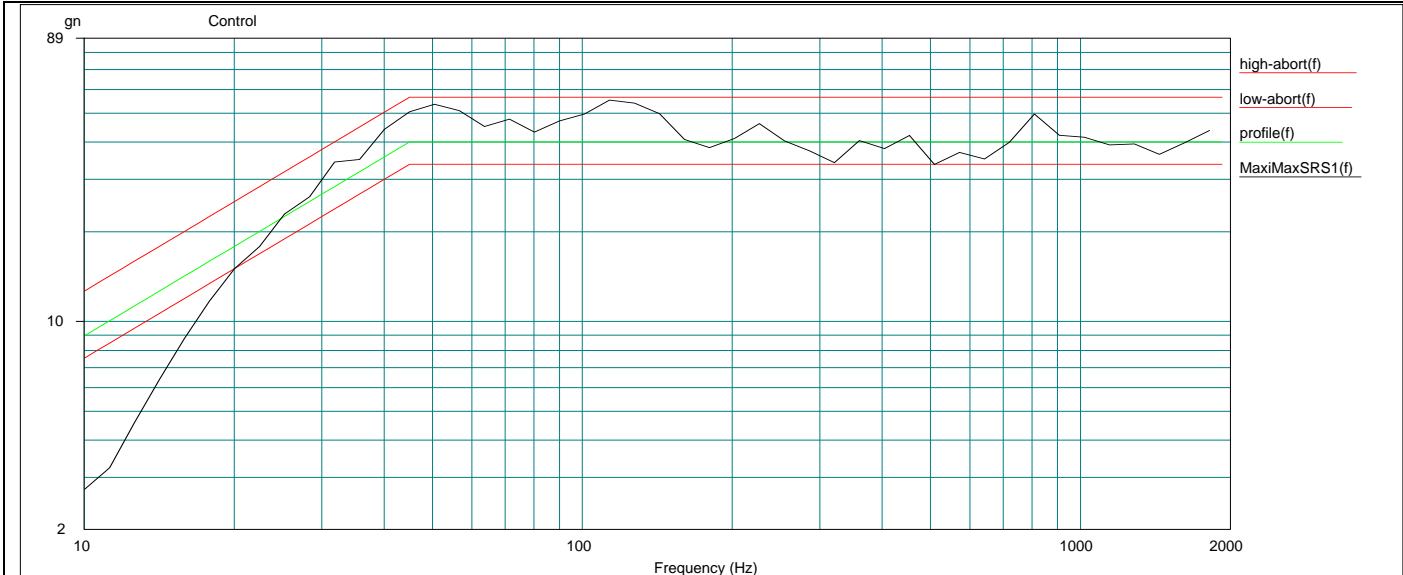
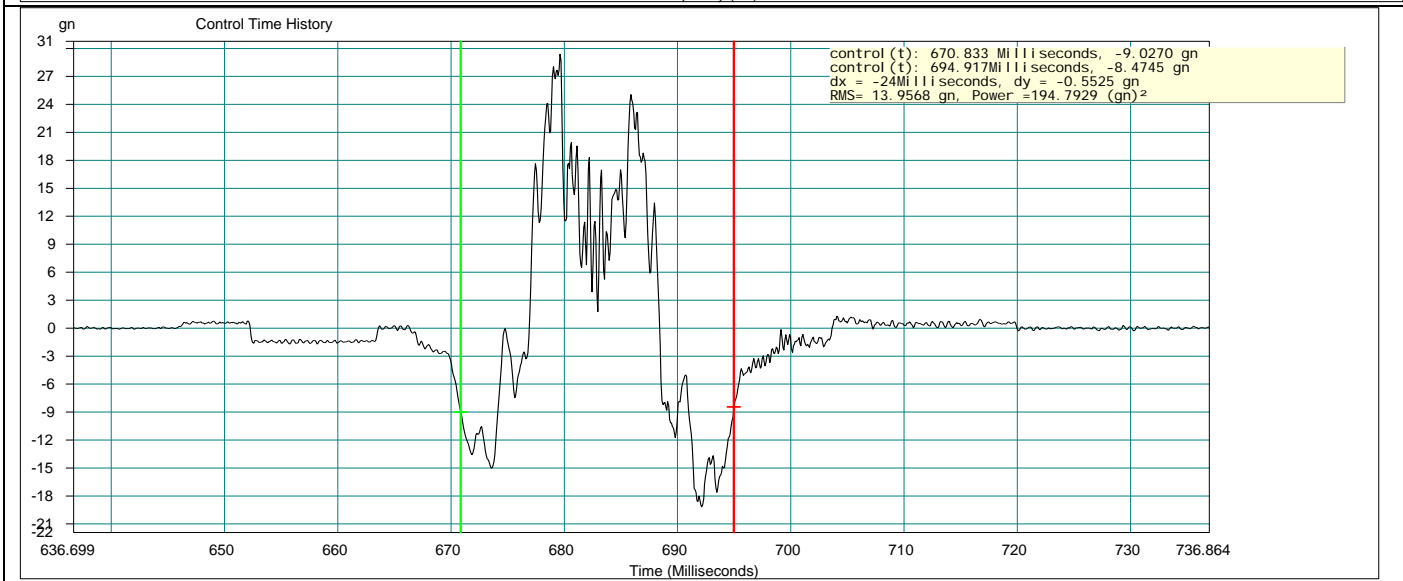
Qualtest, Inc. 5325 Old Winter Garden Road Orlando, Florida 32811 Tel. (407) 293-5844 Fax (407) 297-7376	Customer:	AJs Power Source, Inc.	Job #:	07569
	Test Hardware:	UPS (1 ea.)	Shock #:	1
	P/N:	PG800UPS	Axis:	Vertical
	S/N:	marked "#1"	Direction:	Positive
	Date:	25 March 2011	Time:	1153
