**TEST REPORT**

ENVIRONMENTAL TESTING OF THE P/N PG800UPS UPS

**AJ'S POWER SOURCE, INC.**  
6931 Land O' Lakes Boulevard  
Land O' Lakes, Florida 34638

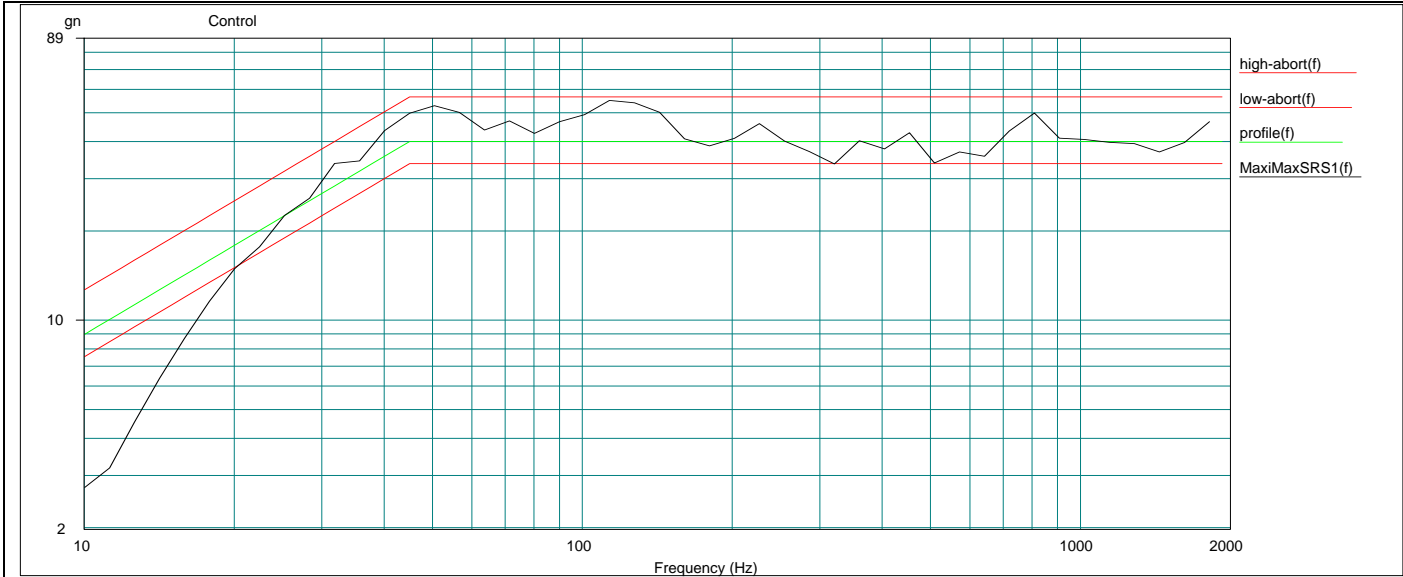
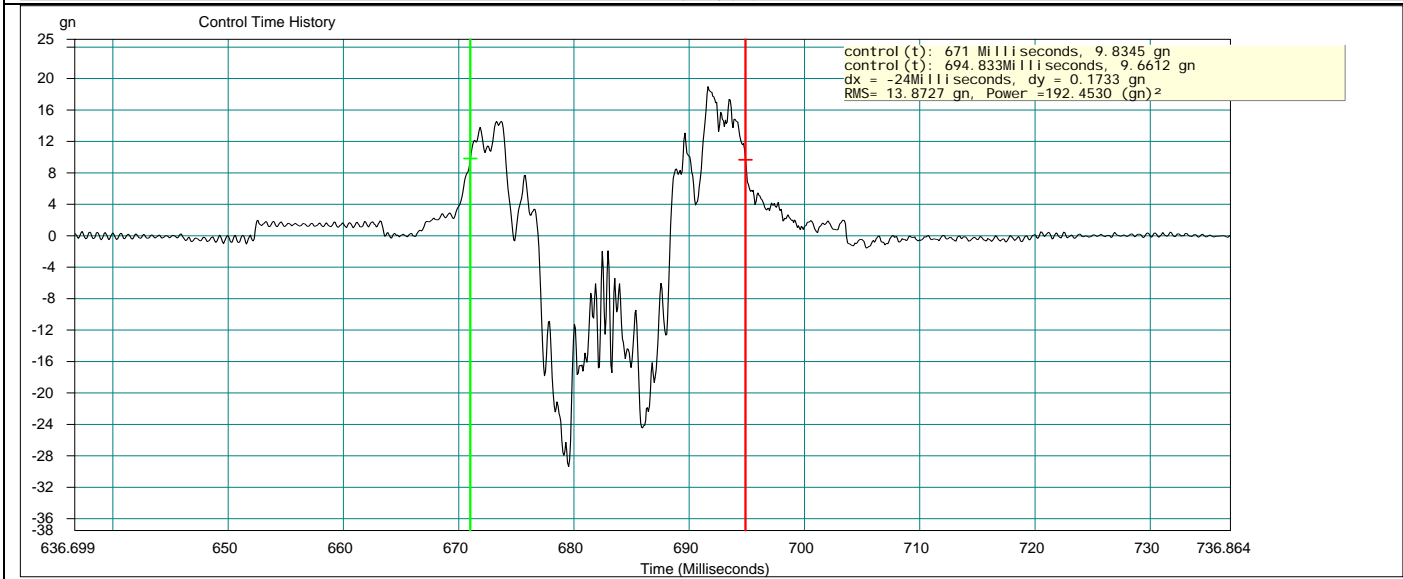
Qualtest, Inc. 5325 Old Winter Garden Road Orlando, Florida 32811 Tel. (407) 293-5844 Fax (407) 297-7376	Customer:	AJs Power Source, Inc.	Job #:	07569
	Test Hardware:	UPS (1 ea.)	Shock #:	2
	P/N:	PG800UPS	Axis:	Vertical
	S/N:	marked "#1"	Direction:	Negative
	Date:	25 March 2011	Time:	1205

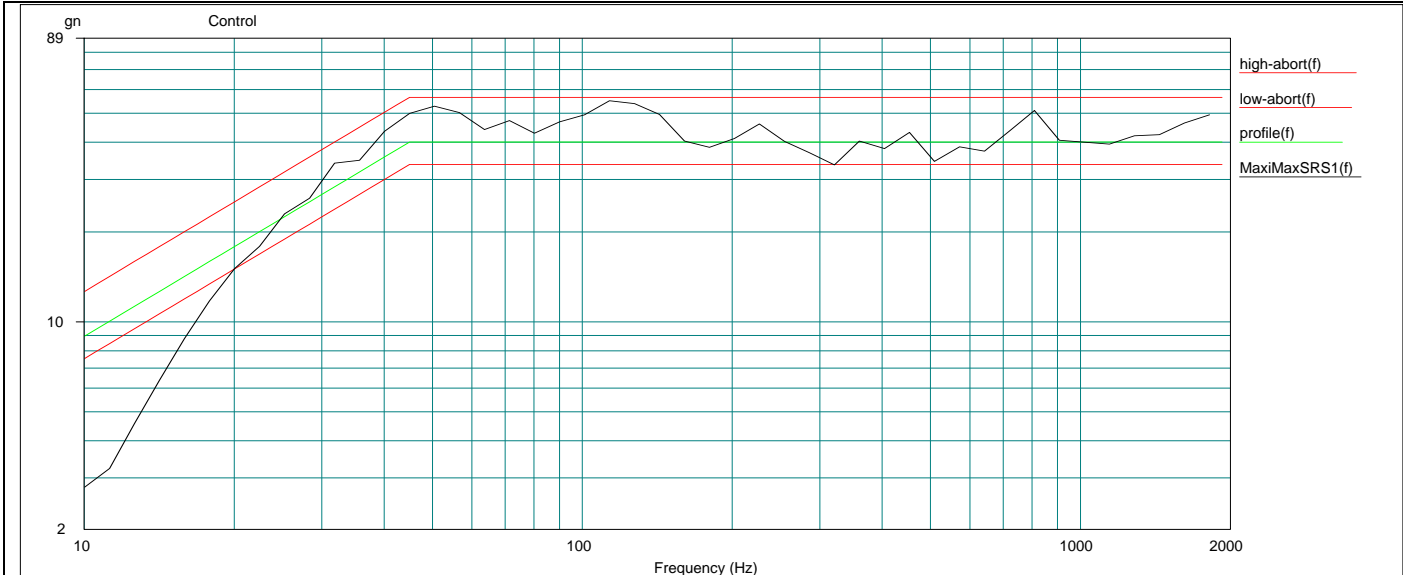
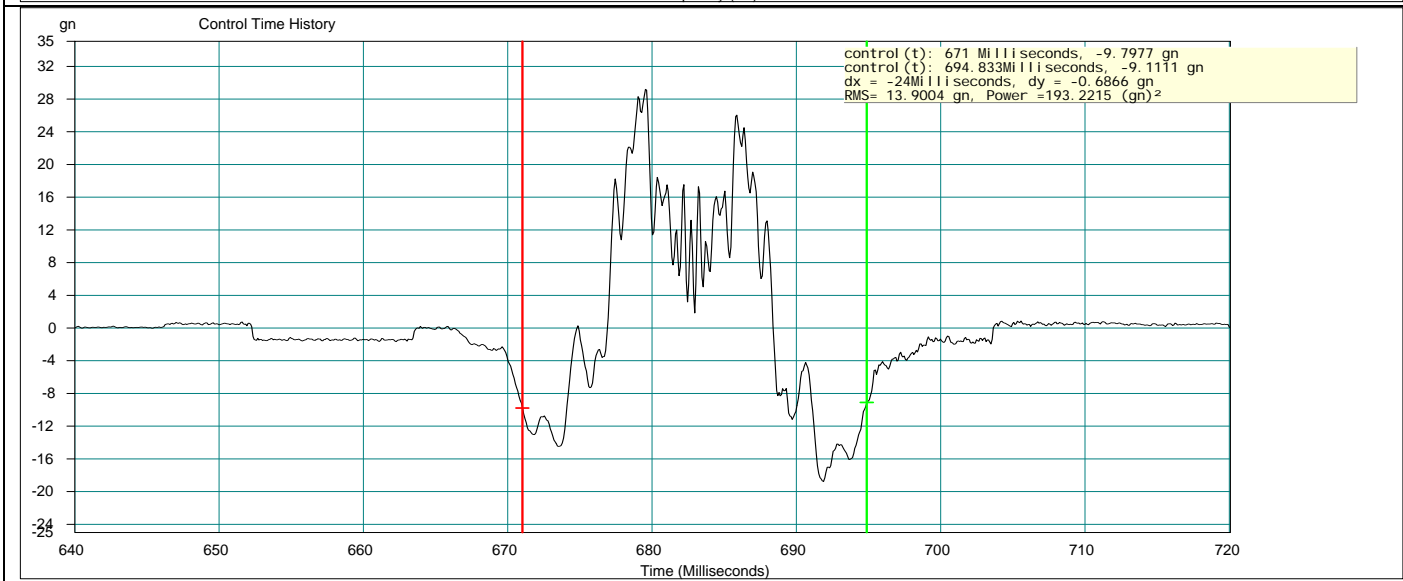
Qualtest, Inc. 5325 Old Winter Garden Road Orlando, Florida 32811 Tel. (407) 293-5844 Fax (407) 297-7376	Customer:	AJs Power Source, Inc.	Job #:	07569
	Test Hardware:	UPS (1 ea.)	Shock #:	3
	P/N:	PG800UPS	Axis:	Longitudinal
	S/N:	marked "#1"	Direction:	Positive
	Date:	25 March 2011	Time:	1640

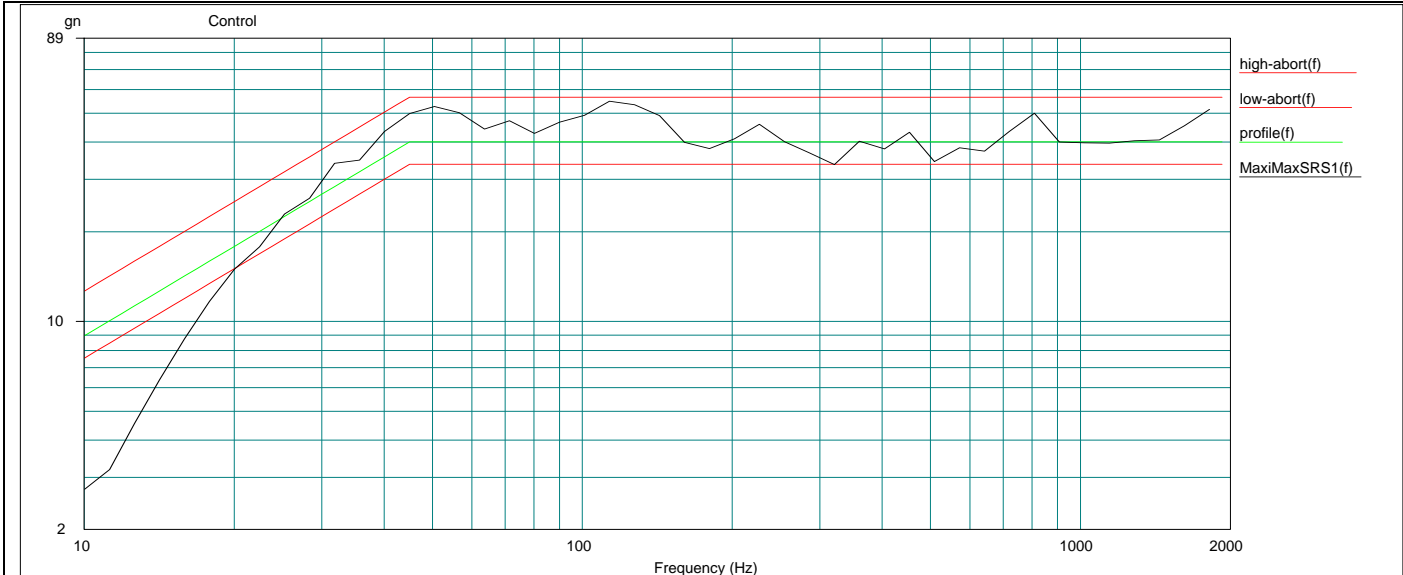
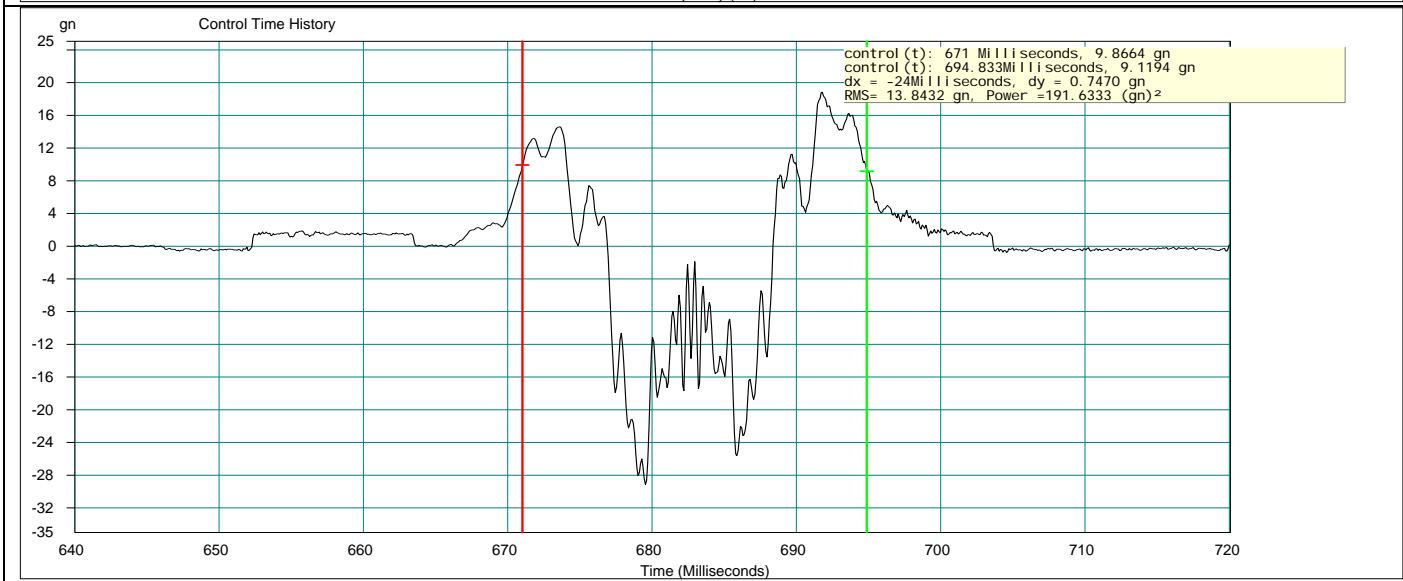
Qualtest, Inc. 5325 Old Winter Garden Road Orlando, Florida 32811 Tel. (407) 293-5844 Fax (407) 297-7376	Customer:	AJs Power Source, Inc.	Job #:	07569
	Test Hardware:	UPS (1 ea.)	Shock #:	4
	P/N:	PG800UPS	Axis:	Longitudinal
	S/N:	marked "#1"	Direction:	Negative
	Date:	25 March 2011	Time:	1648

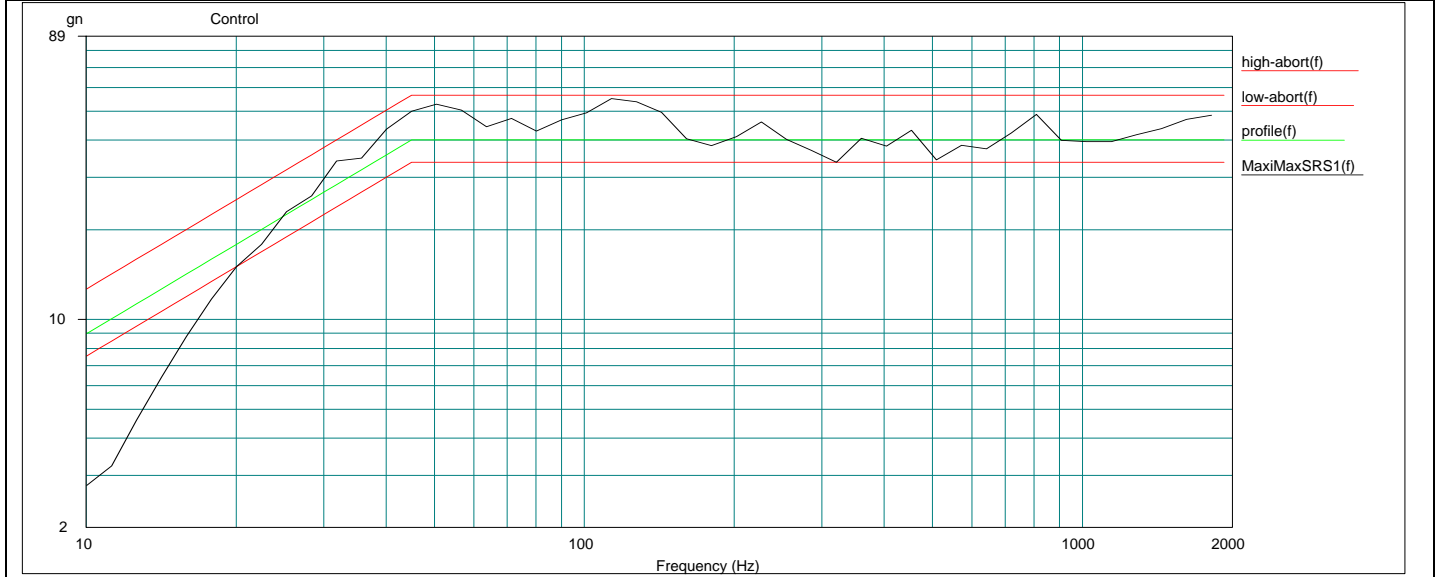
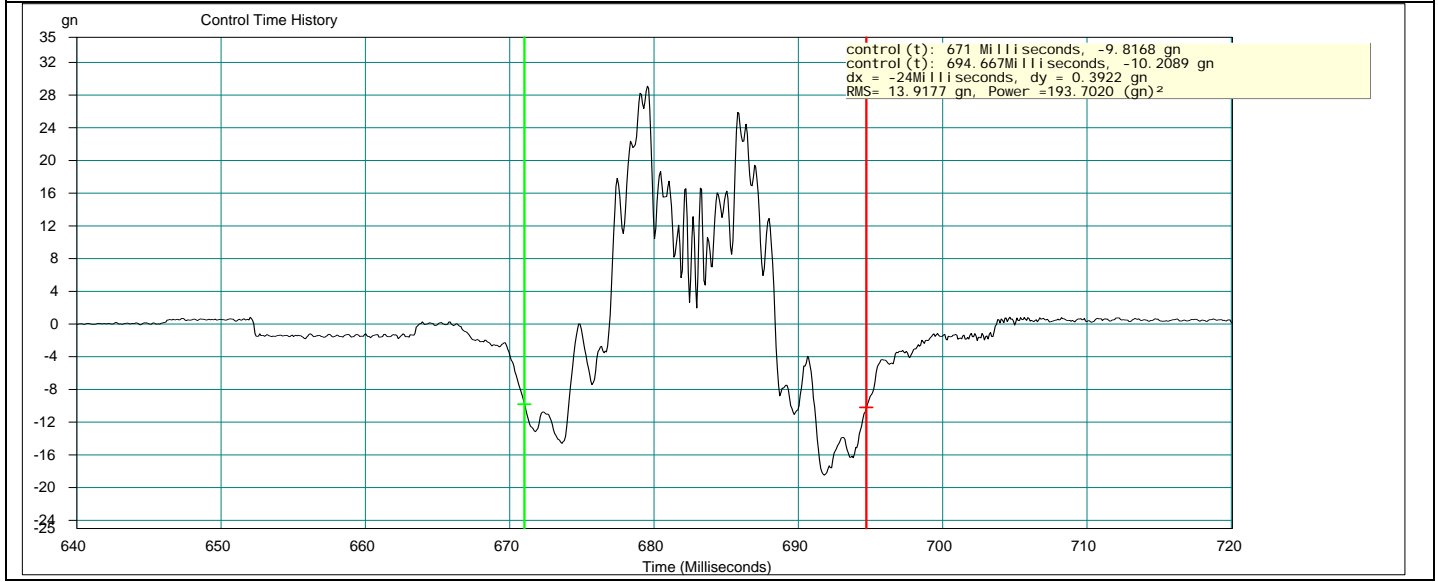
Qualtest, Inc. 5325 Old Winter Garden Road Orlando, Florida 32811 Tel. (407) 293-5844 Fax (407) 297-7376	Customer:	AJs Power Source, Inc.	Job #:	07569
	Test Hardware:	UPS (1 ea.)	Shock #:	5
	P/N:	PG800UPS	Axis:	Transverse
	S/N:	marked "#1"	Direction:	Positive
	Date:	28 March 2011	Time:	0941

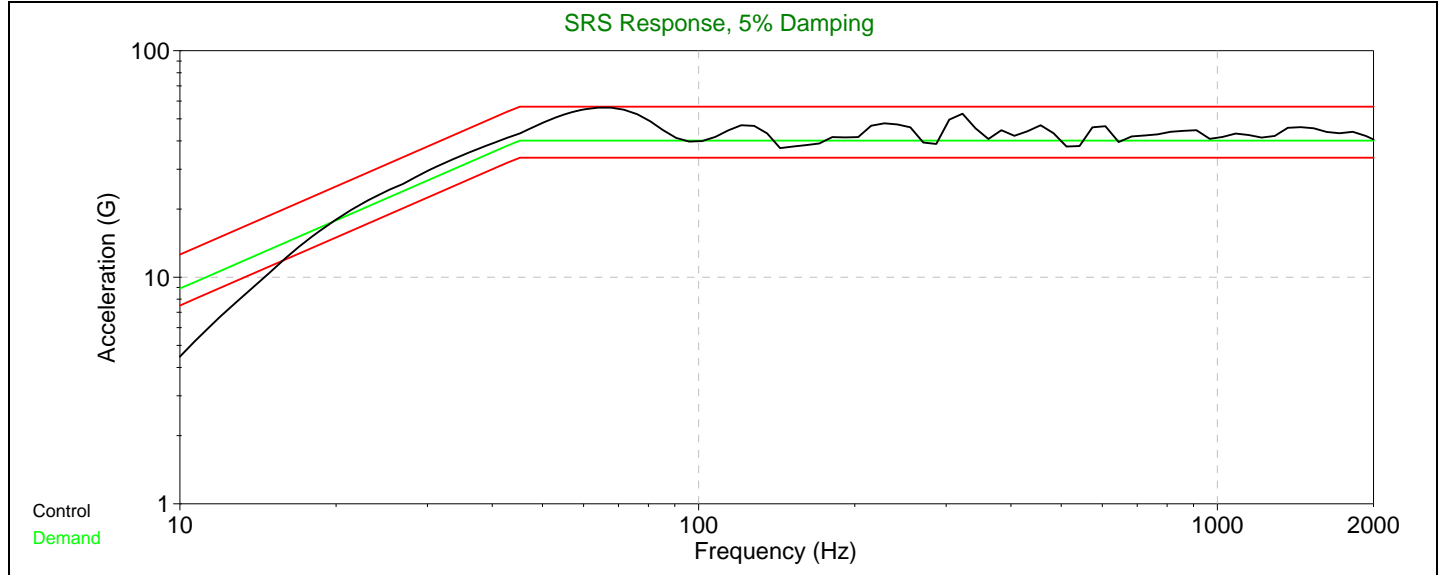
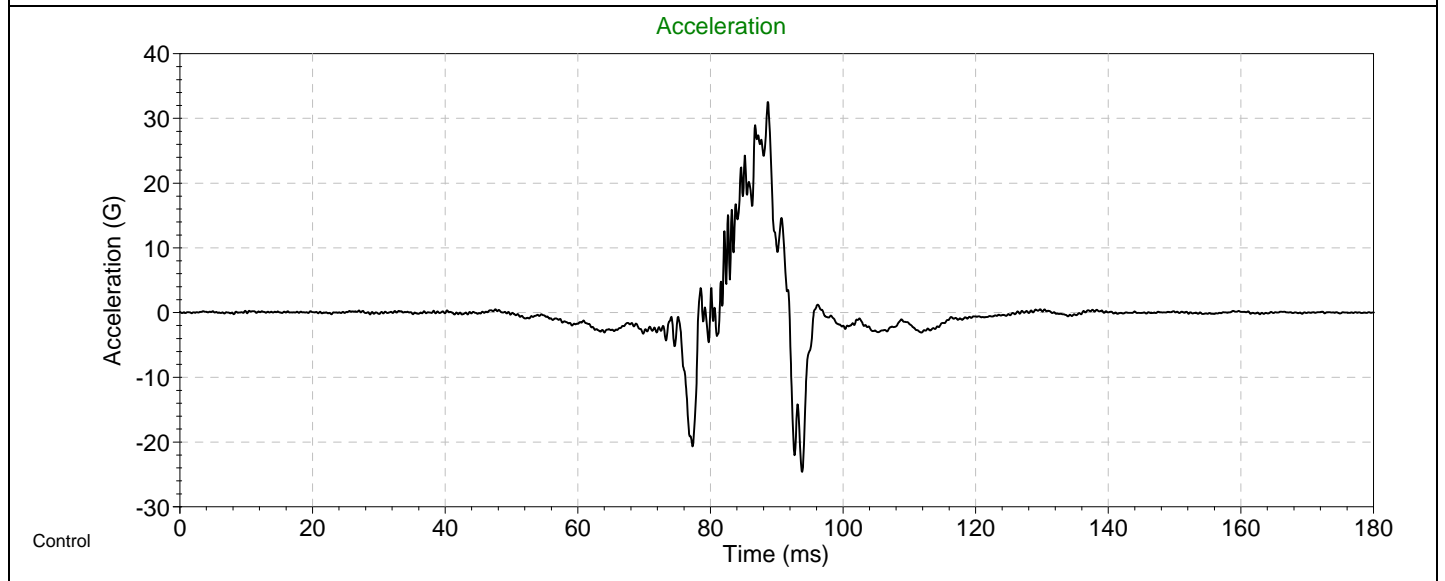
Qualtest, Inc. 5325 Old Winter Garden Road Orlando, Florida 32811 Tel. (407) 293-5844 Fax (407) 297-7376	Customer:	AJs Power Source, Inc.	Job #:	07569
	Test Hardware:	UPS (1 ea.)	Shock #:	6
	P/N:	PG800UPS	Axis:	Transverse
	S/N:	marked "#1"	Direction:	Negative
	Date:	28 March 2011	Time:	1402
